ZCFT-79-39-TJS/RJH  
NOVEMBER 1, 1979

PERFORMANCE OF ALUMINUM  
RIVETED CULVERT  
IN CALIFORNIA

PERFORMANCE OF ALUMINUM RIVETED CULVERT IN CALIFORNIA  
1978 COOPERATIVE CALTRANS-KAISER ALUMINUM SURVEY

T. J. Summerson and R. J. Hogan  
Applications Research

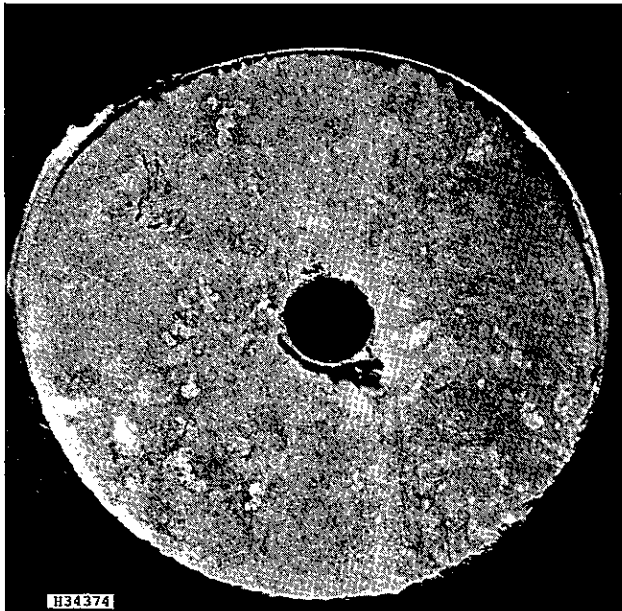
Crown Lap  
4-Feet from Inlet End

Water Side

Soil Side

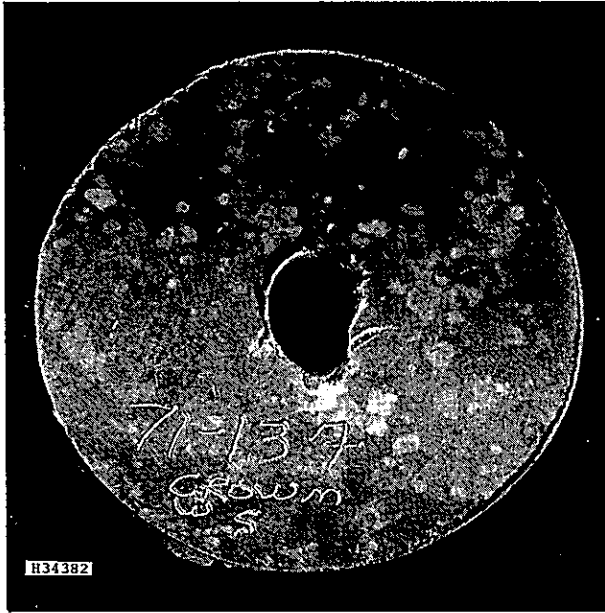
Crown

Water Side

Soil Side

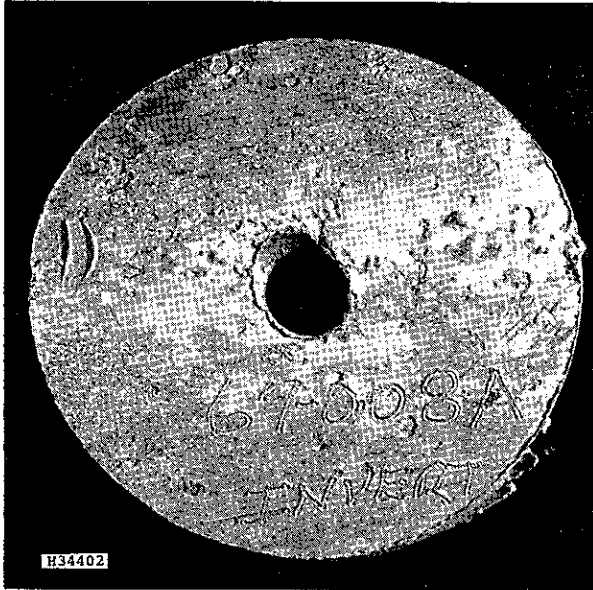
Invert  
West End

Water Side: No corrosion

Water Side

Soil Side

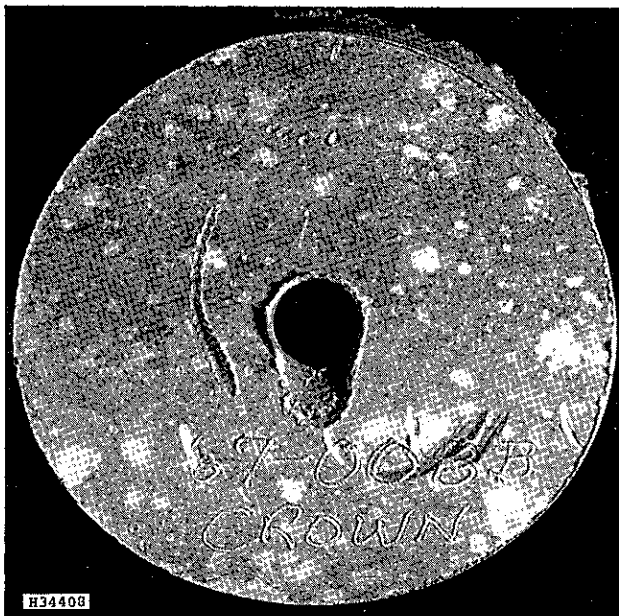
6-Feet from West End

In 1964, the invert was reported to have corroded through (perforated) in 0.83 years. (See Fig. 13 of Nordlin & Stratfull report.) In 1978, the invert (above) was found to be completely corroded through as the result of water side corrosion. However, soil side corrosion is still confined to the cladding thickness. See Figures F54 and F55 in this report.

Water Side

Soil Side

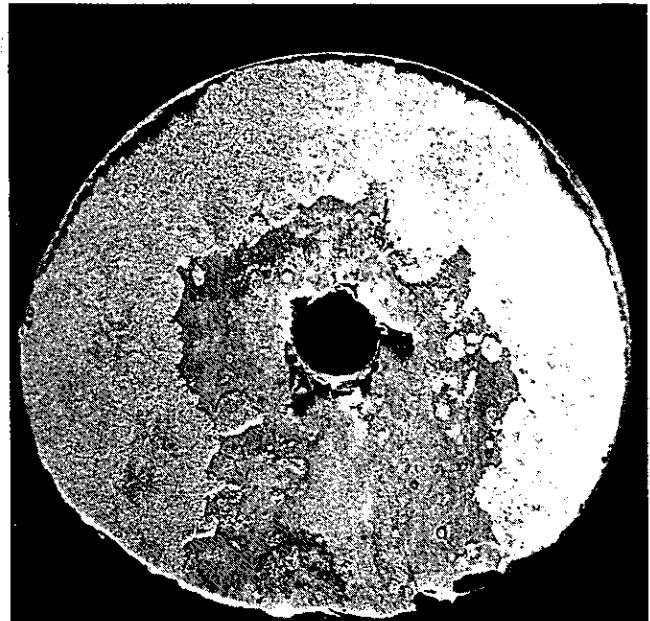
Invert  
17-Feet from Inlet End

Water Side: No attack

Water Side

Soil Side

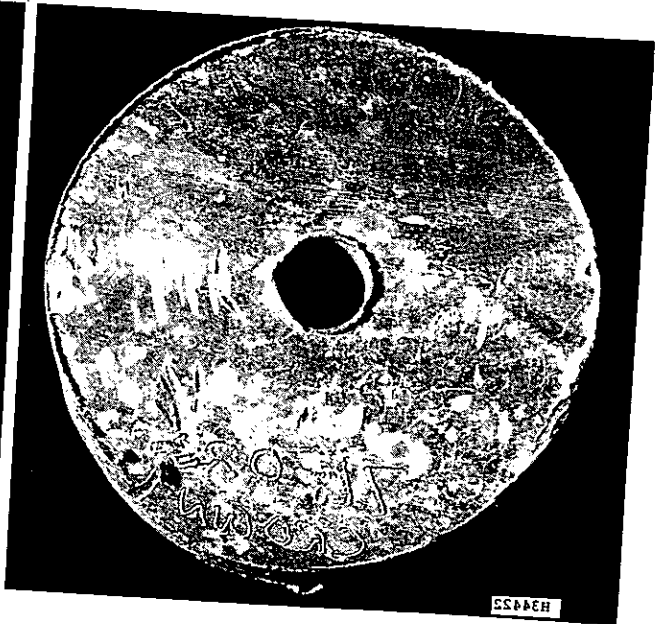
Crown

Water Side: No corrosion present

Water Side

Soil Side

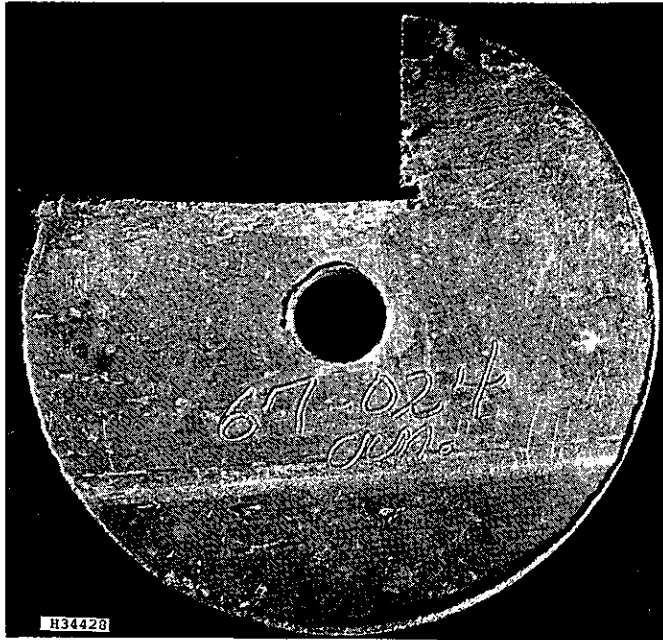
Crown

Water Side: No corrosive attack, scratches  
or mechanical abrasion only

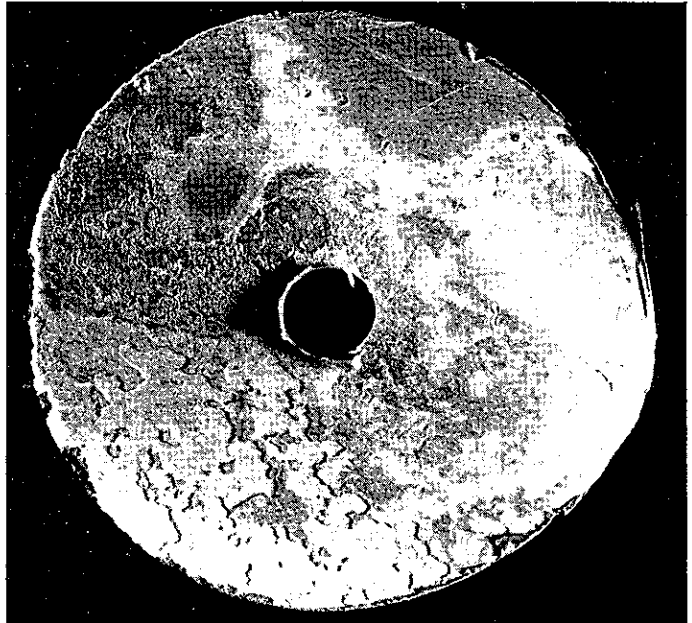
Lap Seam - Invert  
10-Feet from South End

Water Side: No corrosion present

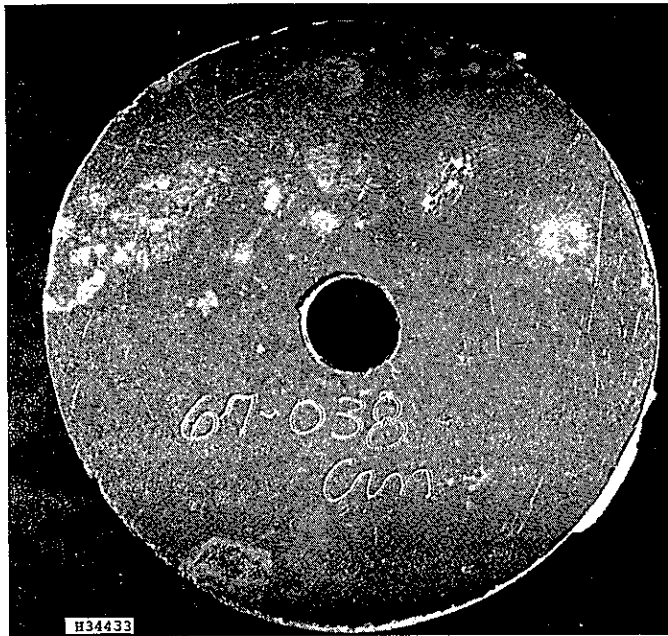
Crown

Water Side: Corrosion of cladding, 0.003 inch

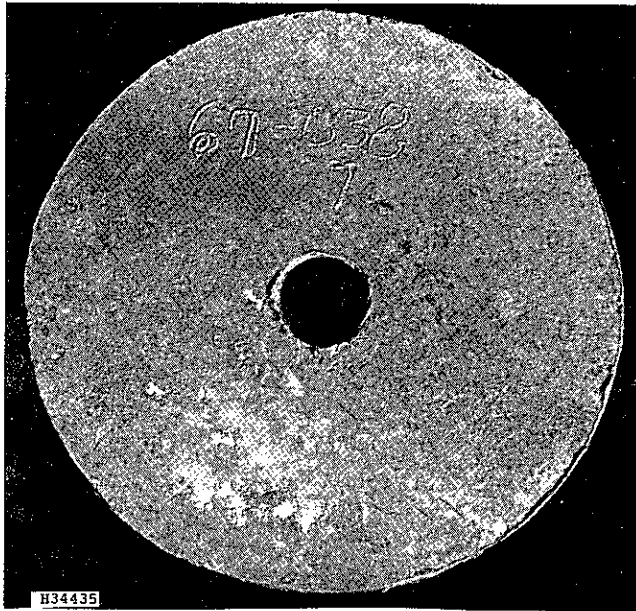
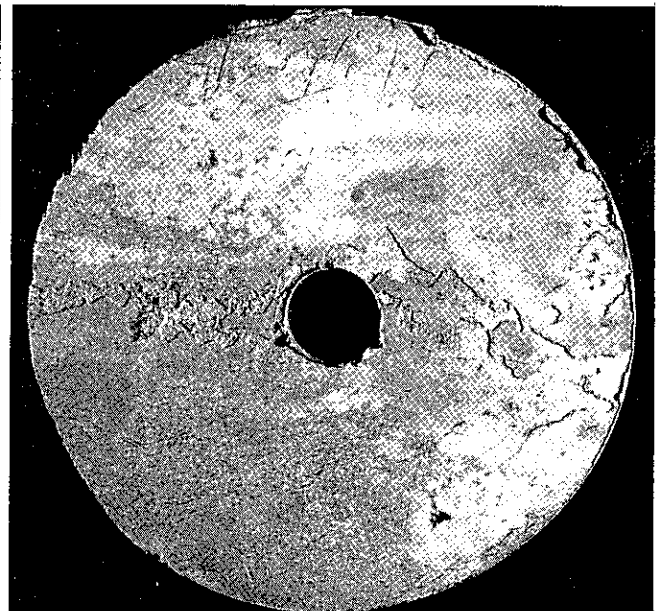
Invert

Water Side: Very small areas of superficial  
etch type corrosion,  $\approx 0.001$  inch

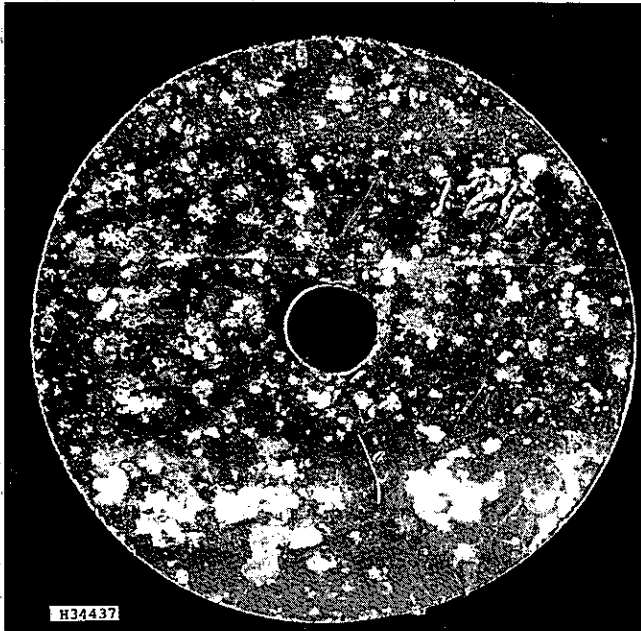
Crown  
9-1/2 Feet from Inlet End

Water Side: Small areas of cladding attack,  
0.002 inch

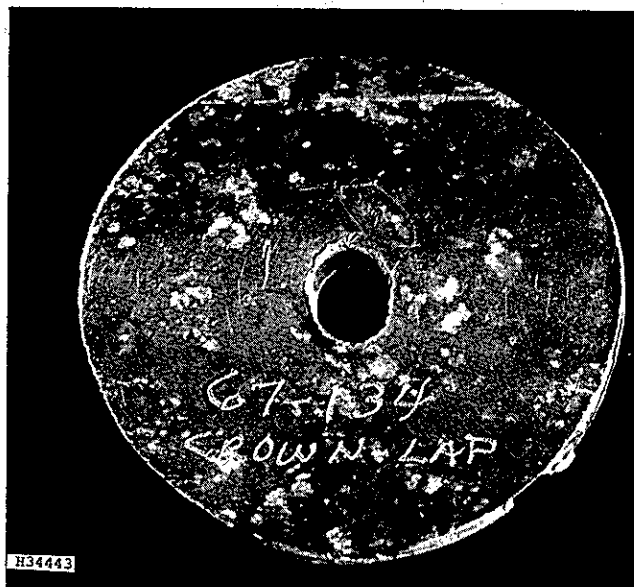
Crown - Lap

Soil Side:      Slight surface etching,  
no measurable corrosion

NOTE:      Mechanical damage to water side of  
coupon during sampling

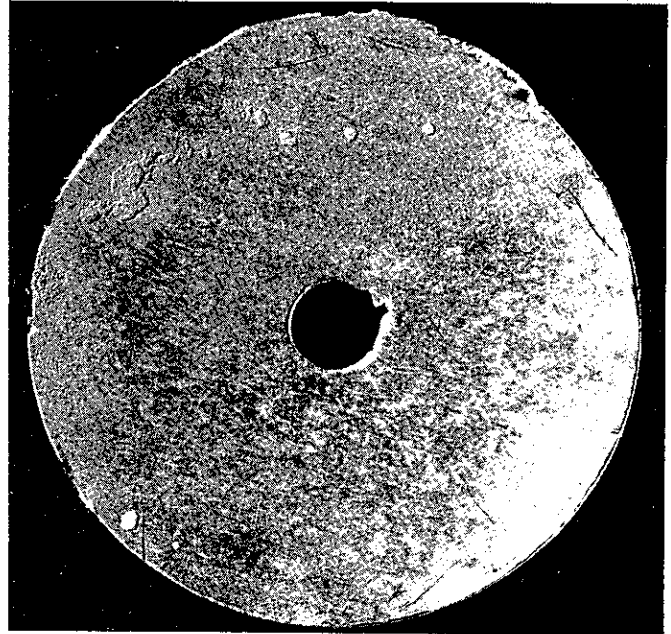
Honch (9 o'clock)  
9-1/2 Feet from Inlet End

Water Side: Slight water staining,  
no measurable attack

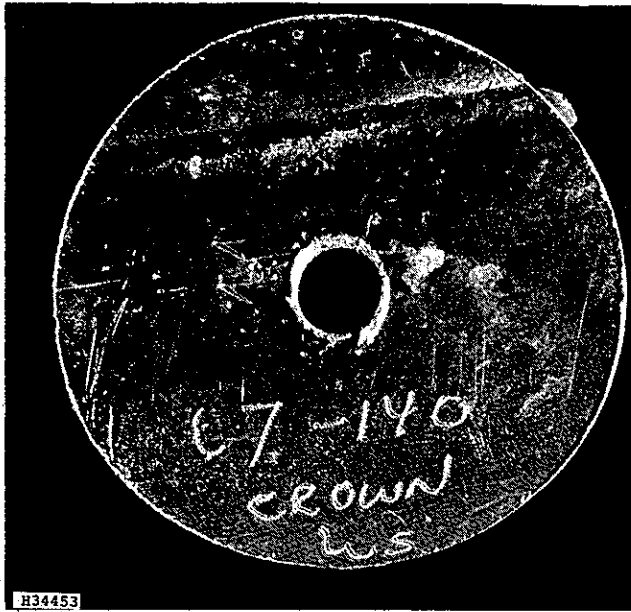
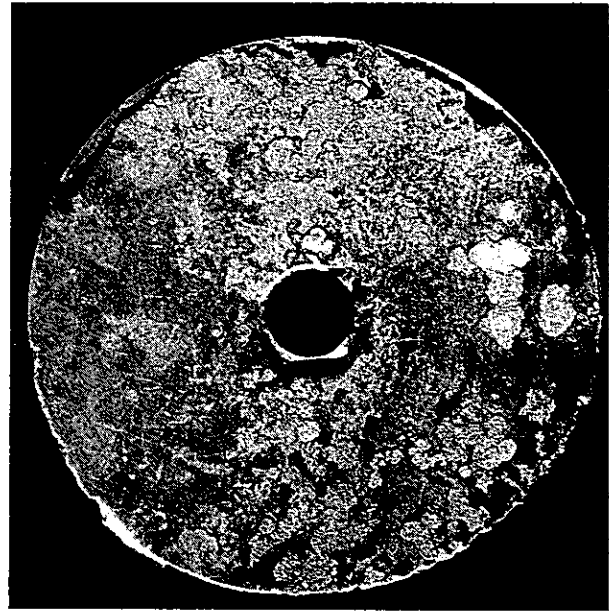
Crown

Water Side: Abrasion of the cladding layer  
to 0.0017 inch.

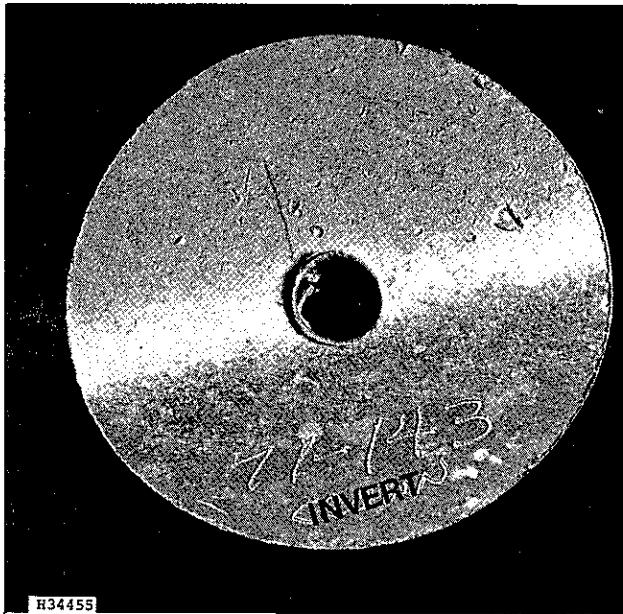
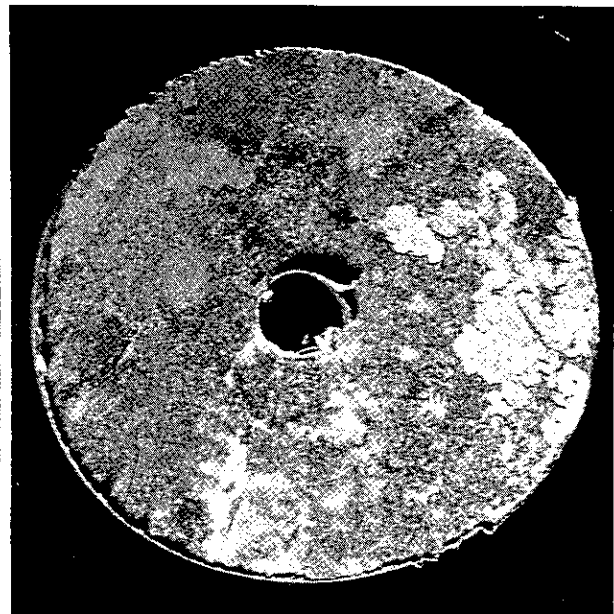
Invert  
20-Feet from Outlet End

Water Side: No corrosion

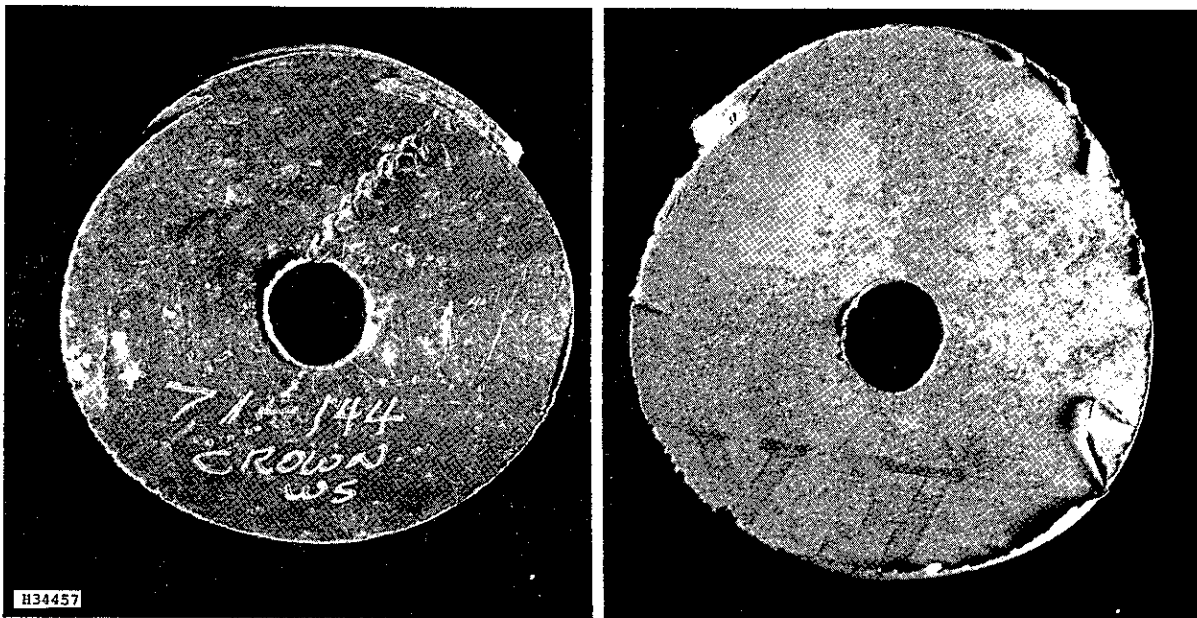
Crown  
31-Feet from Inlet End

Soil Side: Corrosion limited to the cladding  
layer, 0.0038 inch

Water Side: Abrasion of cladding layer  
0.0025 inch deep

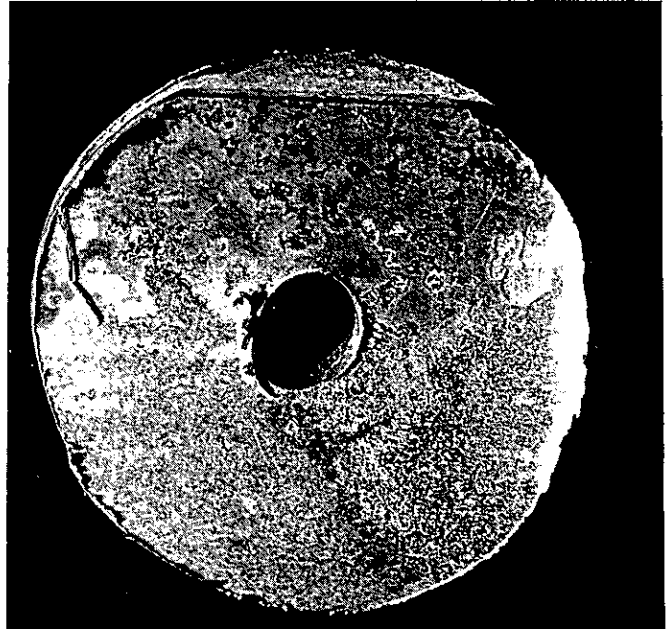
Springline Lap  
32-Feet from Inlet End

Water Side: No attack

\*Water side of coupon mis-identified as "lap-side"

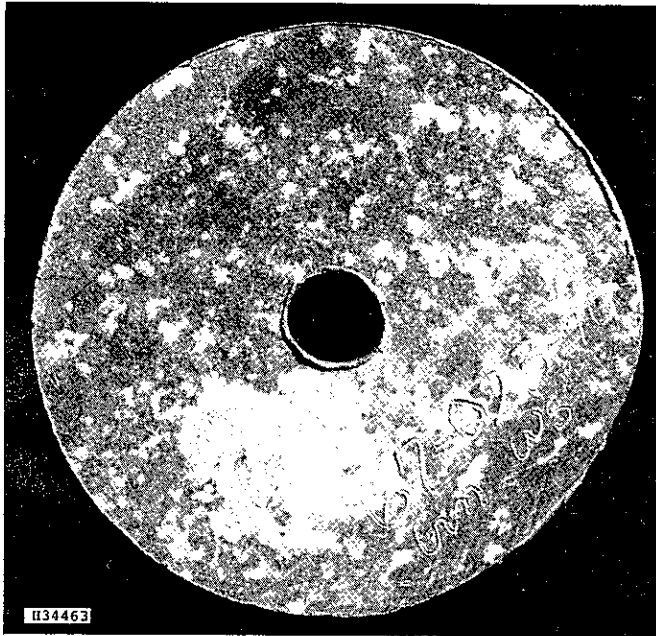
Crown

Sample reported as "in excellent condition."

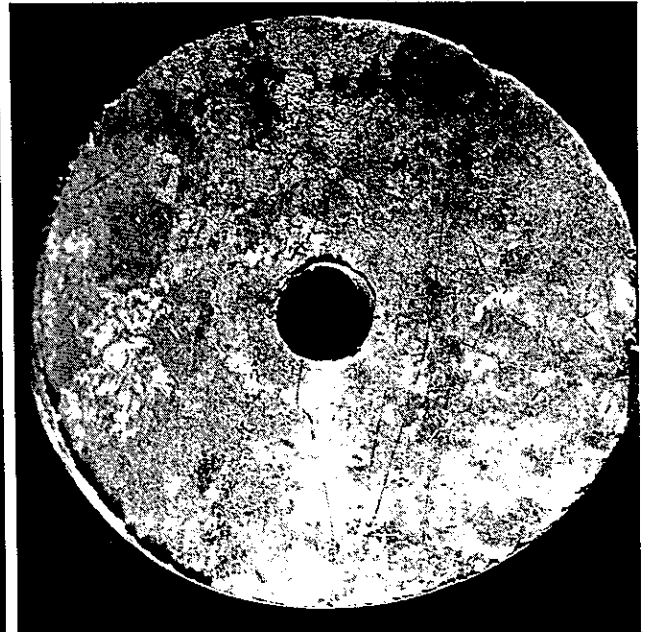
Honch Lap  
5 Feet from Outlet End

Water Side: Perforated from soil side corrosion

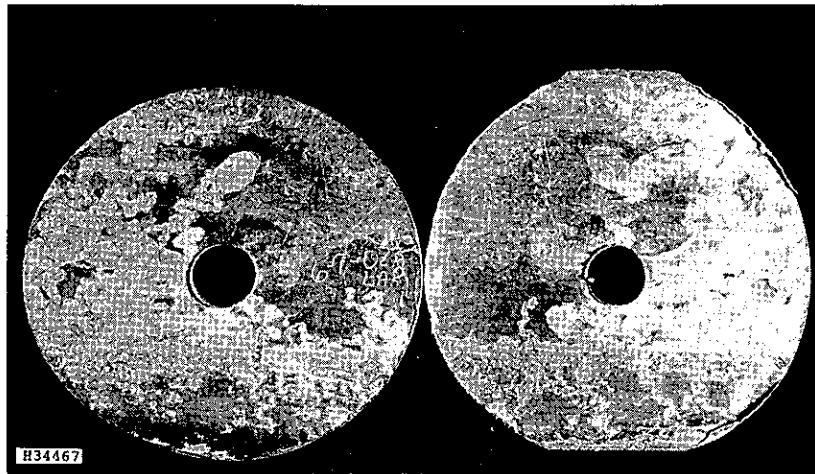
Honch (Lap Interface)

Lap Interface:       Attack of the cladding  
                          layer, 0.0038 inch

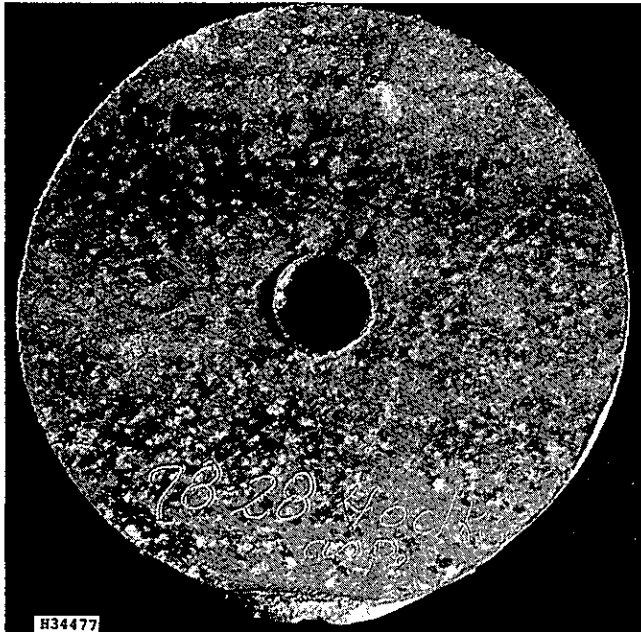
Soil Side: Attack of the cladding layer,  
0.0068 inch

Water Side: Abrasion of the cladding layer,  
0.0035 inch

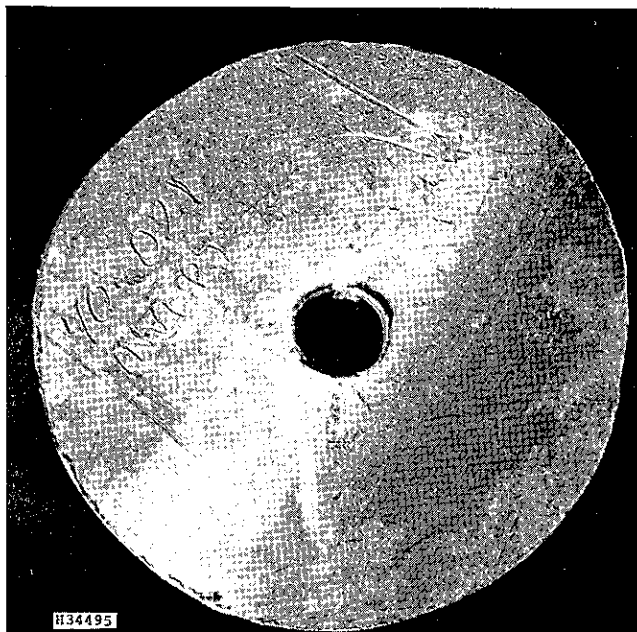
Invert  
4-Feet from Outlet End

Soil Side: Corrosion limited to the cladding  
layer, 0.0038 inch

Water Side: Water condensate staining,  
no measurable attack

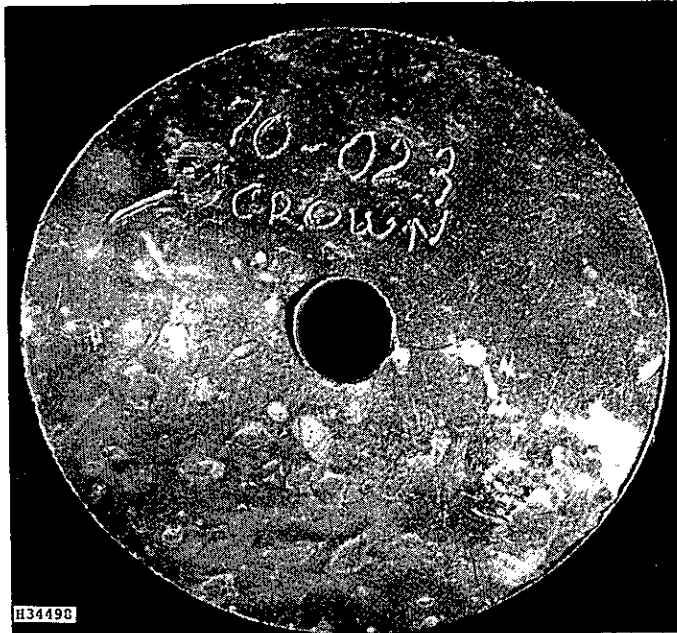
24-Feet from Inlet End

Photo and visual inspection show culvert  
was extremely dirty and appears to be in  
excellent condition
